Tartan 37 Technical Resources

Chapter 2: Sails and Rigging

Section 3: Chainplate Islands

Court Crosby # 249 Dragonfly

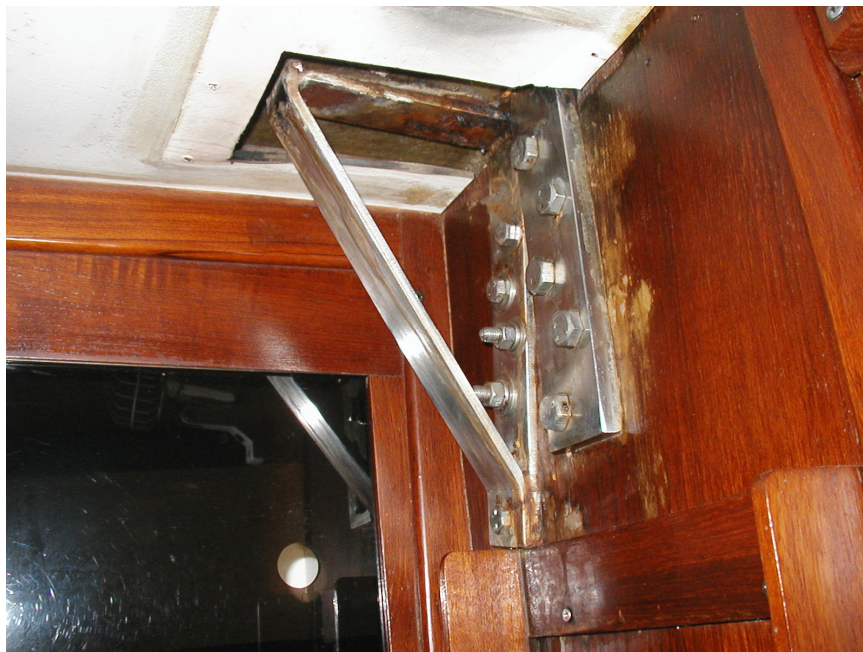
With the trim removed, this looked a lot worse. What I had originally thought was varnish from the trim was rust.

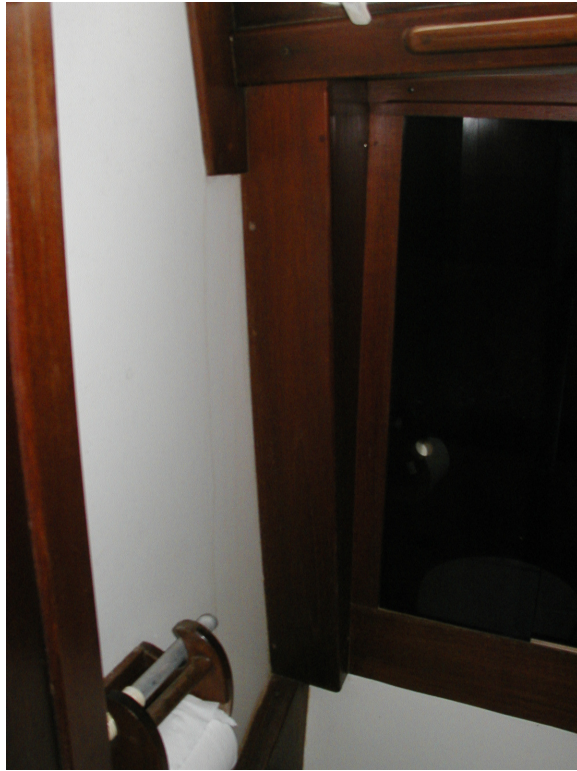
The trim in the head had to be removed to get to the bolts.

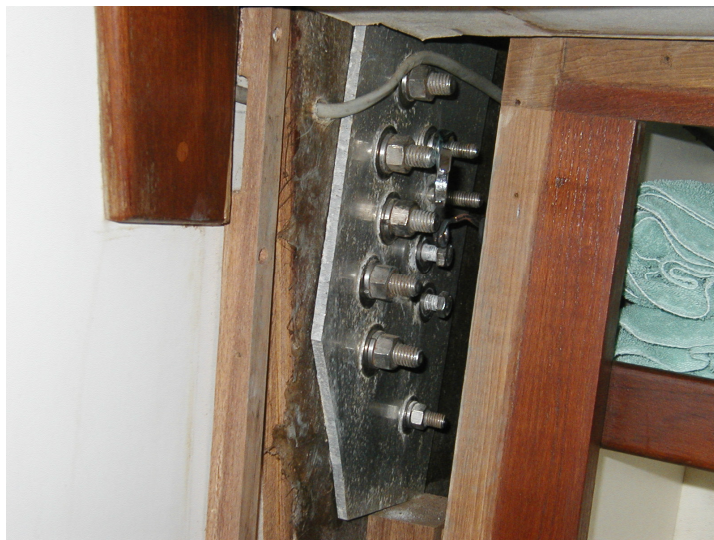
Vice-grips on one side and a wrench on the other allowed me to remove the bolts alone (although two of them had to be cut off).

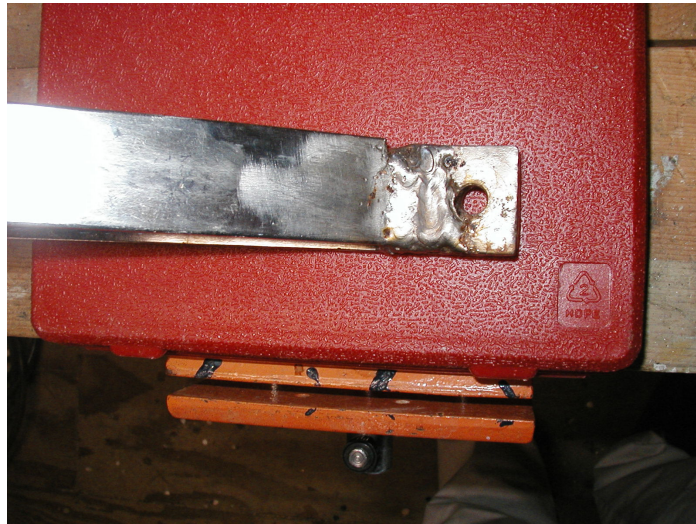
This is the starboard chainplate, welded where it had apparently broken just above the bottom hole. It was about to fail again just above the weld.

I took the port chainplate to a full service boatyard to have a new one fabricated. The starboard chainplate had failed at some time earlier, I could tell by the still evident smile in the deck where it had torn when the chainplate came through, and that chainplate looked new compared to the port side. I had to pull it anyway to make an island. To my surprise, it had been repaired, not replaced. It was about to fail again, and when it had been repaired it hadn't been completely straightened out. To make it fit the installer had cut the bottom surface and core out of the deck! I changed my order to two opposite hand chainplates, and had a nut welded to the second hole from the bottom on the starboard one because there was no way to get fingers to it behind the trim.

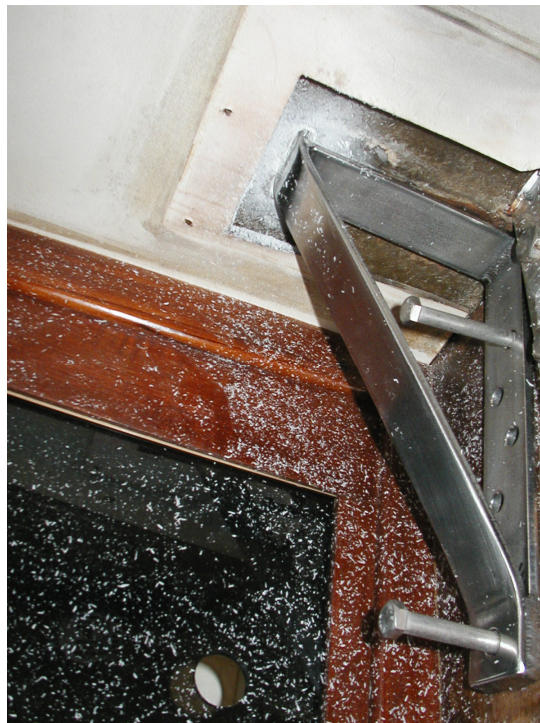
It took a while with a rotary cutting bit to get the holes sized to accept the new chainplates. By the way, I don't like this chainplate design. Too much of the load is carried by the bottom bolt.
