Tartan 37 Technical Resources

Chapter 1: Hull and Deck Structure

Section 2: Replacing Balsa In a Cored Deck

Byron Higgins, #444 La Vieve

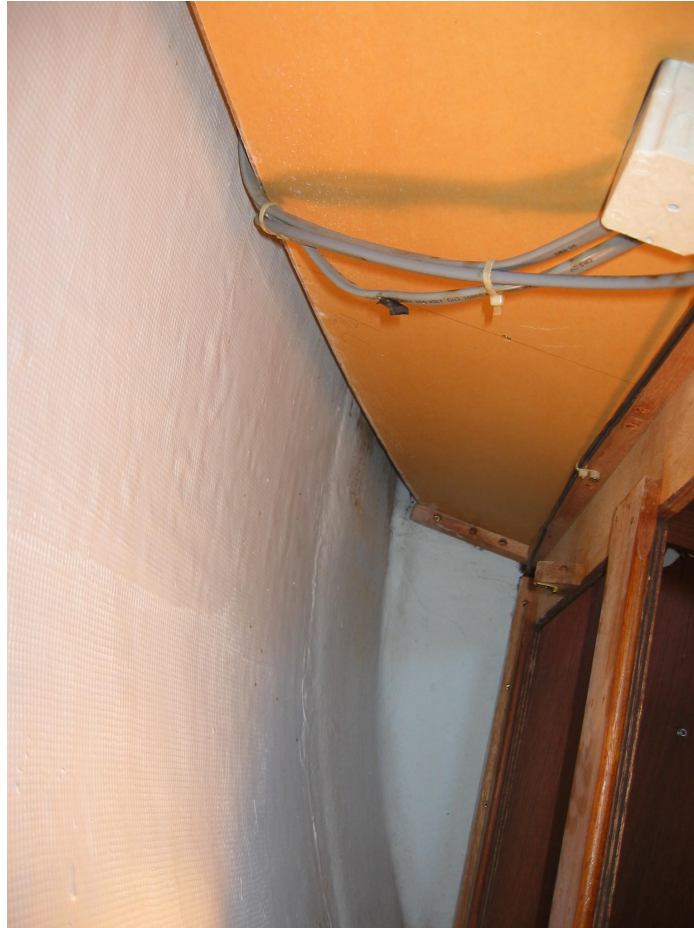
Note the brown stain in the upper middle, a sign of the problem. This is the main cabin, port side, looking forward.

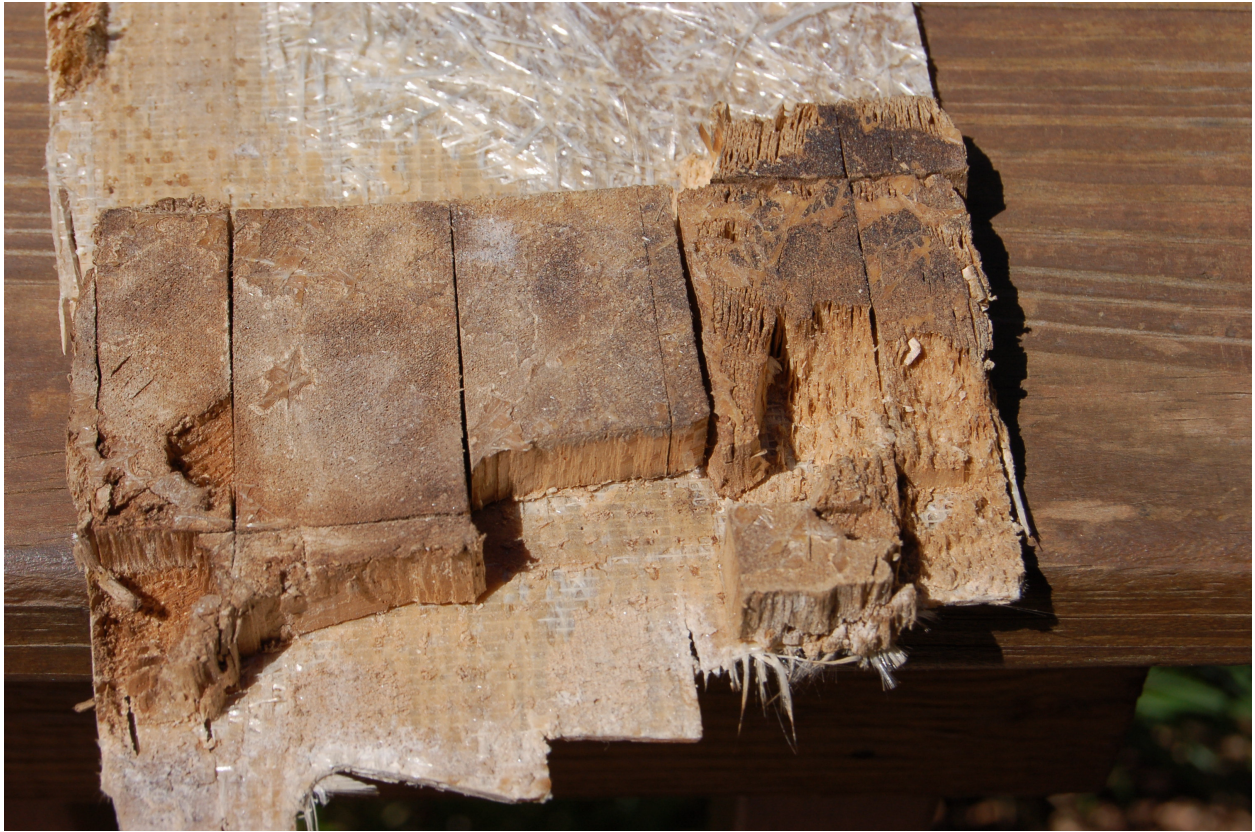
In a core deck, the balsa is located between two layers of fiberglass – the lower layer of fiberglass must be cut away to access the balsa. Here is what it looks like when it has been removed (the lower part is the bottom of the sandwich, what you see on top is a single sheet of fiberglass that holds the balsa core together when it was originally installed, IT IS NOT THE DECK):

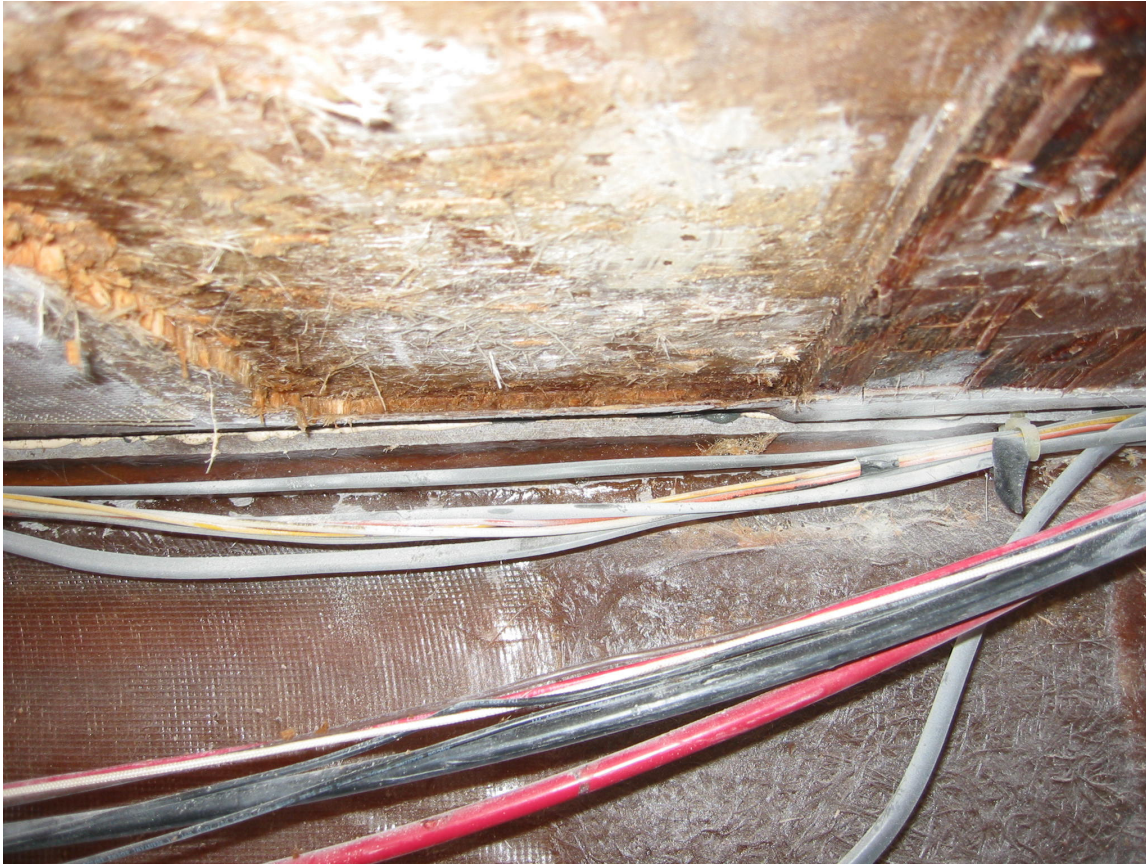
I was not sure how thick the balsa core was, so I had to be careful about how deeply I cut into this lower layer of fiberglass - I did not want to accidentally cut through the core and the upper layer of fiberglass (the deck). As it turns out, the balsa core in my Tartan 37 is $\frac{1}{2}$ inch thick. To cut away the lower fiberglass layer, I used my trusty Dremel. When doing this, you want to wear a mask and throwaway clothing because the dust is fiberglass particles. There was no question of where the heart of the problem with the core was and I began my cut there. I extended it in small sections searching for uncontaminated balsa. This required several cuts until I reached solid balsa. Here is a photo of the area with the balsa removed.

Once you have removed the fiberglass, you can remove the contaminated balsa. Again, it will be wet and very soft. Once it is removed, you will want to scrape the underside of the deck to remove remnants of the bad balsa and the original adhesive. Next, allow the area to dry. I let it sit for the entire winter, and continued the job the following spring. When it is dry, you will gently and carefully sand the underside of the deck to prepare it for repair – it must be clean. Once it has been sanded, wipe it down with lacquer thinner to remove any contaminants. Now, you are ready to replace the core. At this point, you should clean the work area of debris and dust.
